# Study shows methods considered competent only 10 years ago can result in an unsafe repair today.

A research project carried out by KTI GmbH & Co in Germany shows that **improperly repairing collision damage, especially in newer vehicles constructed with high tech materials, will lead to an unsafe vehicle in subsequent collisions.**

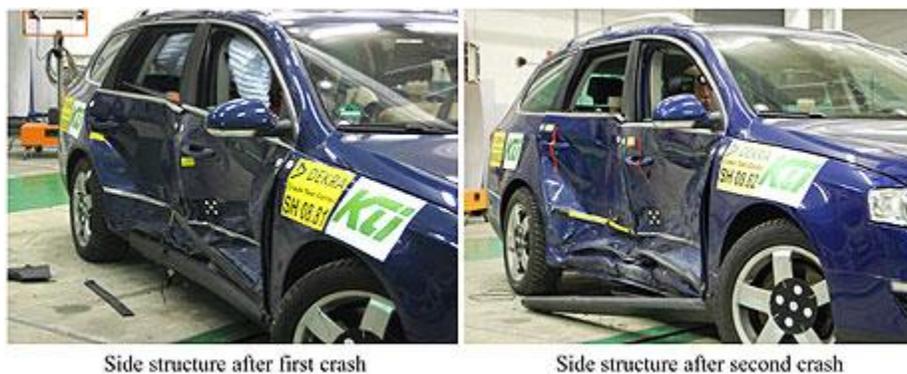
**"It was immediately evident that there was a substantial difference, with far more comprehensive deformation of the car body after the second impact. The B-pillar**

had noticeably higher intrusion into the passenger compartment in comparison with the first crash, especially at the lower part at the connection with the sill," the report showed.

Measurement of the car body confirmed there was 60 mm (2.3 inches) more intrusion after the second test, compared to the first crash.

Other differences noted by KTI included damage to areas that were unaffected by the initial crash due to the change in load paths caused by the substandard repair. The roof and the transmission tunnel both displayed severe deformation not seen in the first crash, and the top right corner of the windshield was damaged in the second crash.

**The OEM procedure calls for complete replacement of the B-Pillar and other deformed components constructed with high strength steel. Repairing these components is not acceptable because the structure and strength of the material is severely degraded by welding and reforming.**
